TESTS OF REINFORCED CONCRETE FLAT SLAB STRUCTURES

BY
ARTHUR N. TALBOT
And
WILLIS A. SLATER

BULLETIN No. 84
ENGINEERING EXPERIMENT STATION

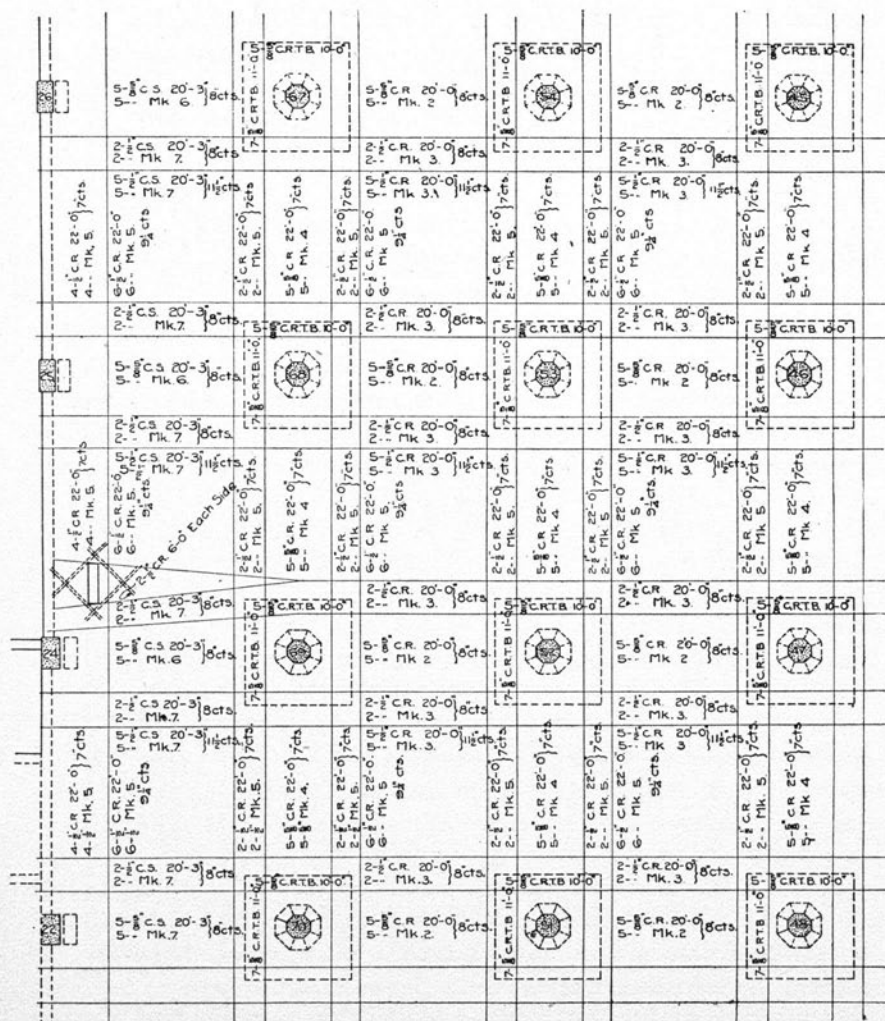
FIG. 1. DISTRIBUTION OF REINFORCEMENT FOR TEST FLOOR OF SHREDDED WHEAT FACTORY.

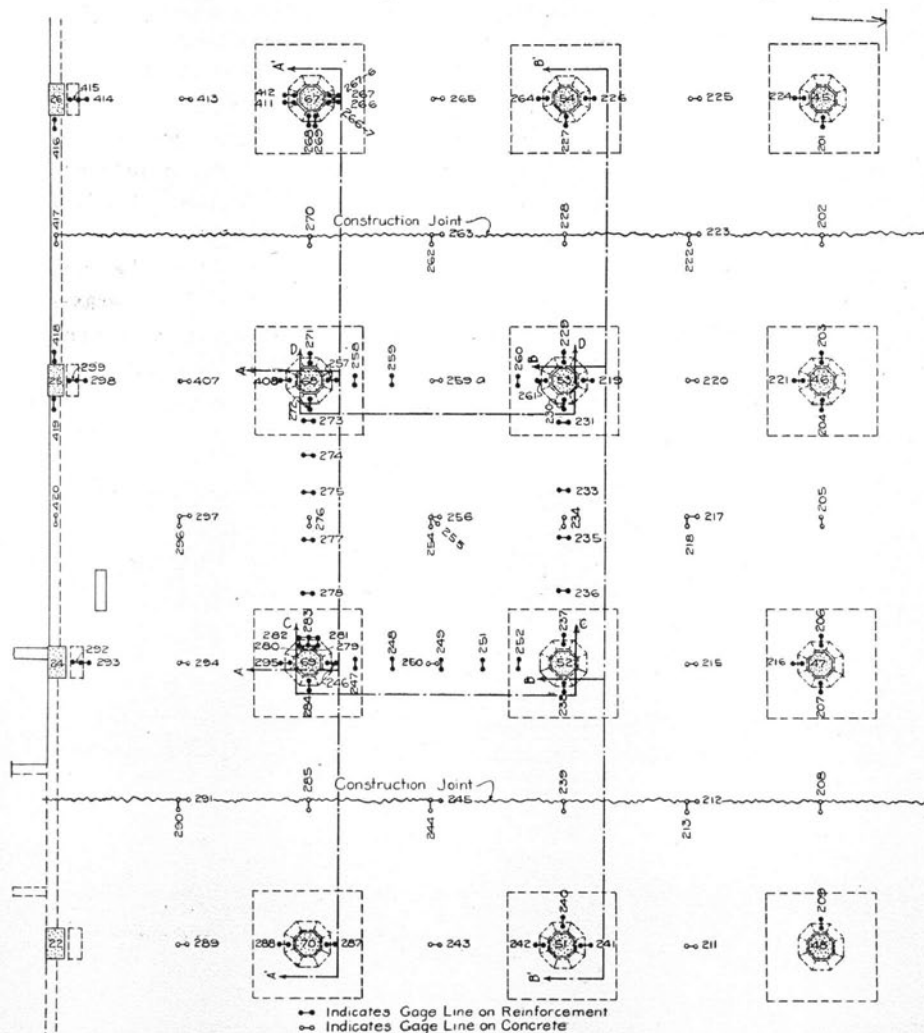
FIG. 3. LOCATION OF GAGE LINES ON UPPER SURFACE OF TEST FLOOR OF SHREDDED WHEAT FACTORY.

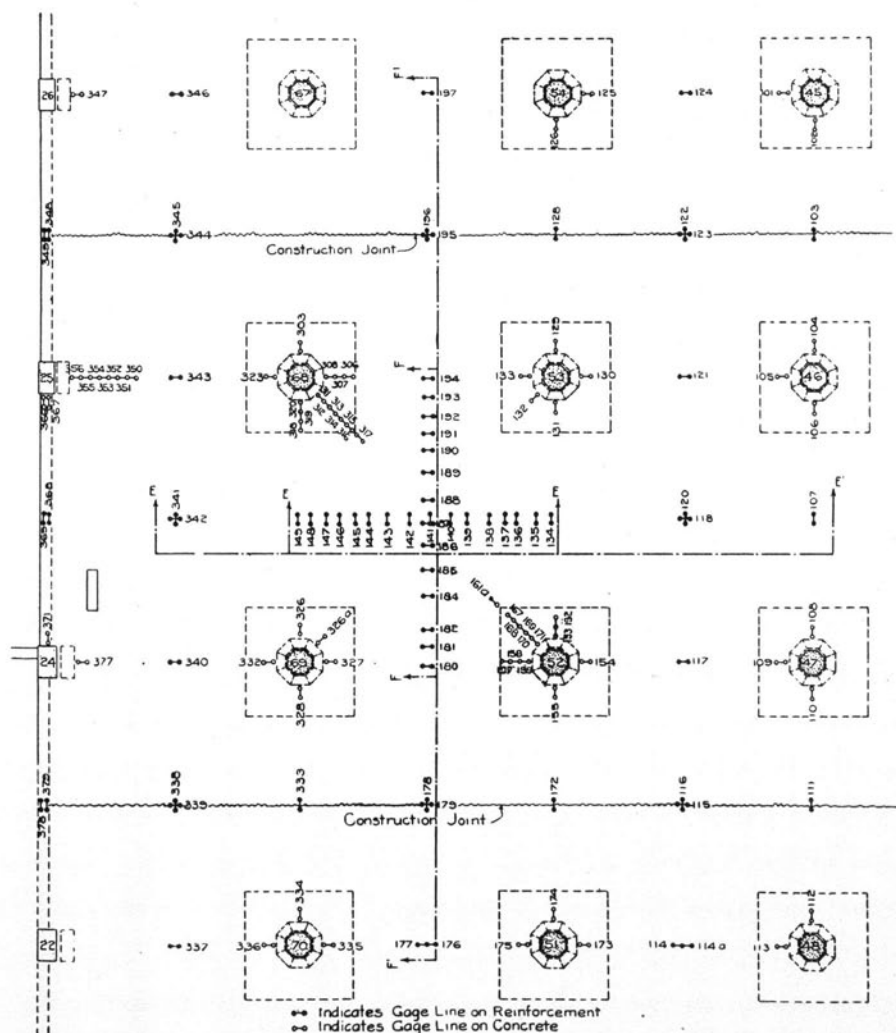
FIG. 4. LOCATION OF GAGE LINES ON UNDER SURFACE OF TEST FLOOR OF SHREDDED WHEAT FACTORY.

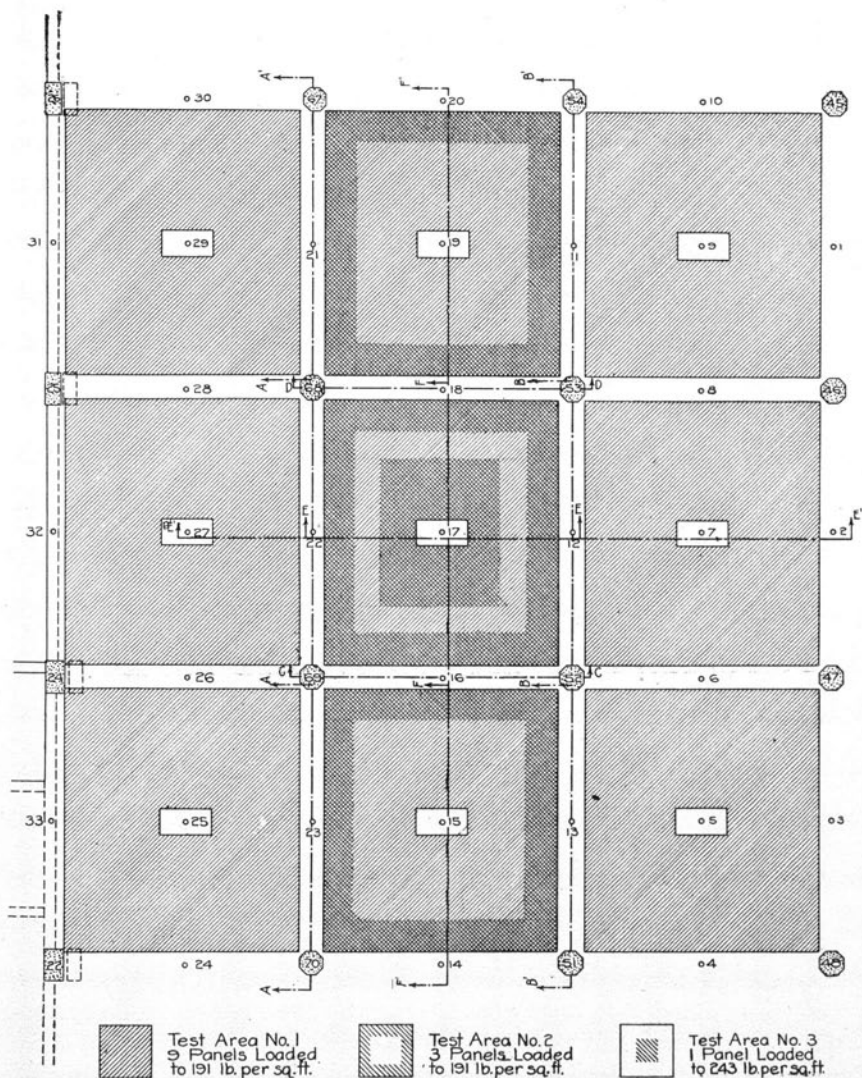
FIG. 6. LOCATION OF DEFLECTION POINTS AND PLAN OF LOAD DISTRIBUTION AT THREE SUCCESSIVE STAGES OF TEST OF SHREDDED WHEAT FACTORY FLOOR.

Nine panels were first loaded (see Fig. 6). Strain gage observations were made at loads of 56, 120, and 191 lb. per sq. ft. The 191-lb. test load was allowed to remain in position two and one-half days. The load was then removed from the three wall panels and from the three panels farthest from the wall, leaving three panels loaded as shown in the figure. Strain gage observations were taken with this load in place. Next, the two outer panels of the three were unloaded and the load on the center panel was increased to 243 lb. per sq. ft.

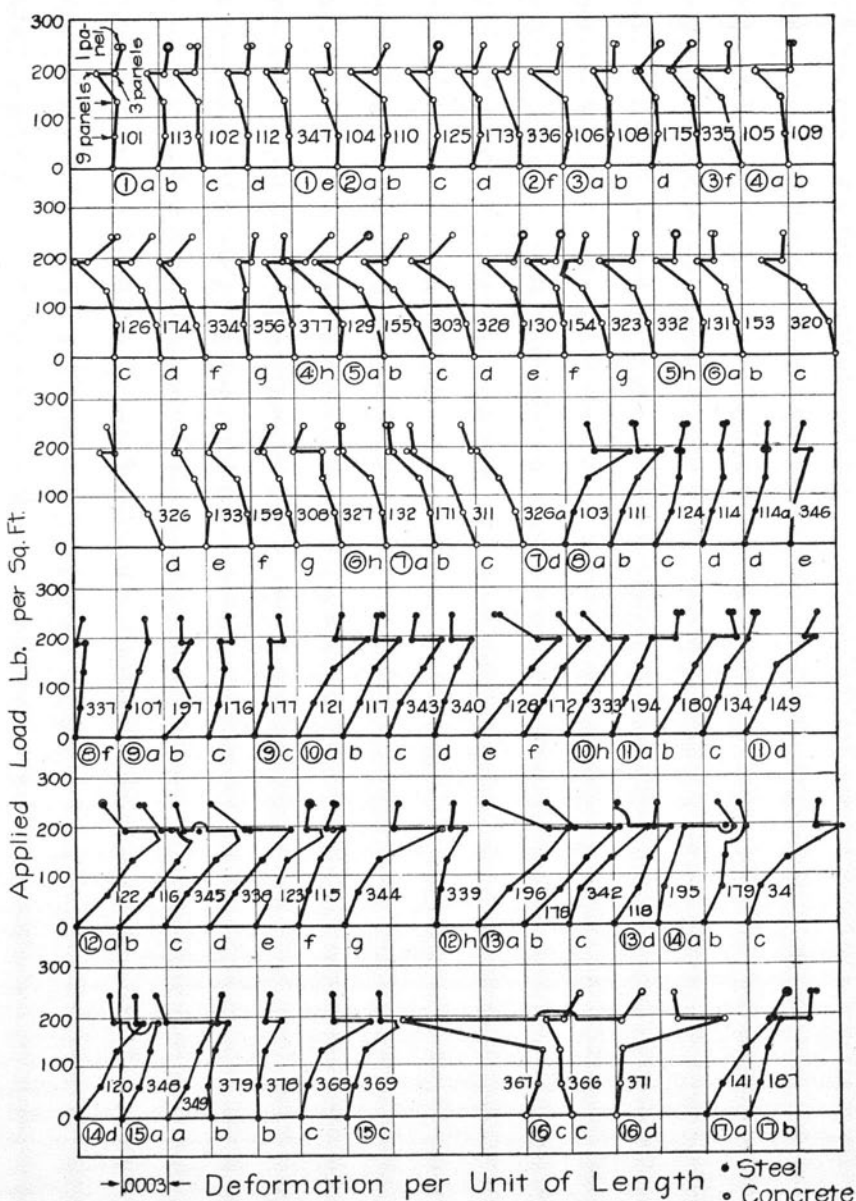
FIG. 8. LOAD-DEFORMATION DIAGRAMS FOR GAGE LINES ON UPPER SURFACE OF TEST FLOOR OF SHREDDED WHEAT FACTORY.

6. *Load-deformation Diagrams.*—The load-deformation diagrams have been plotted in Fig. 8 and 9, the grouping being such as to

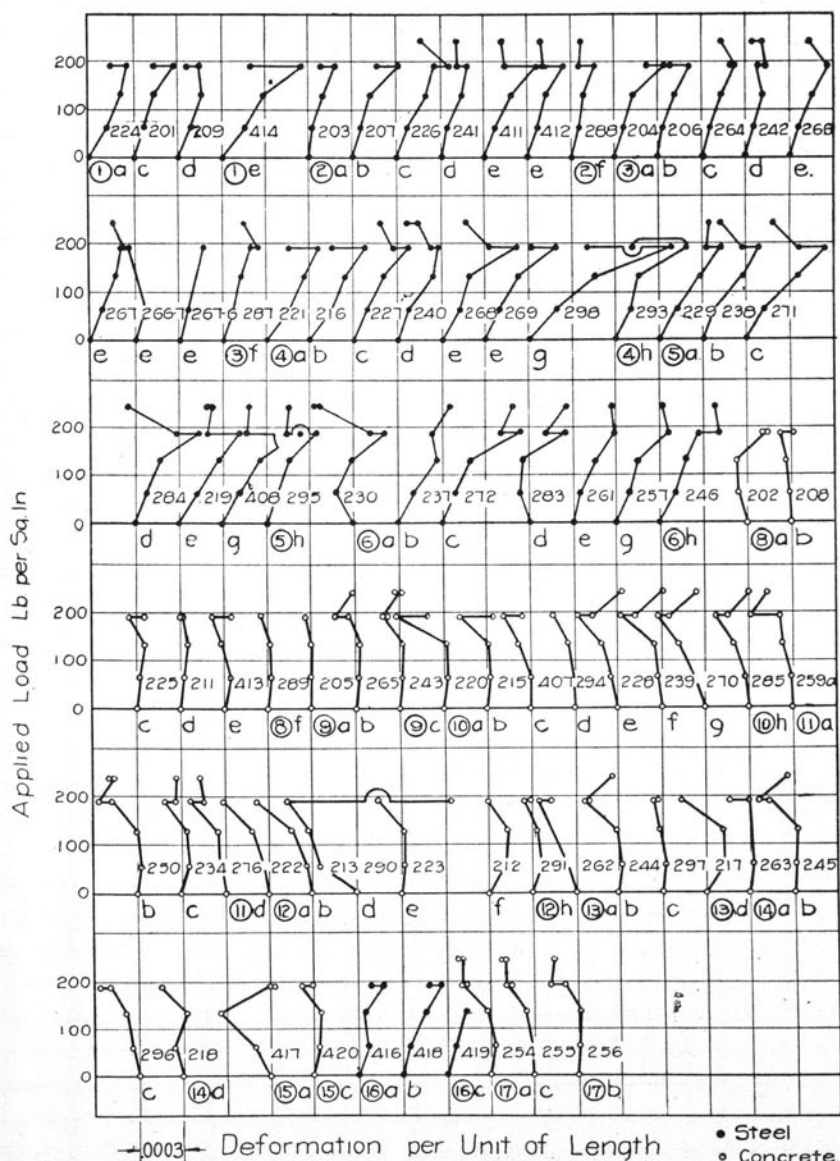
FIG. 9.—LOAD-DEFORMATION DIAGRAMS FOR GAGE LINES ON UNDER SURFACE OF TEST FLOOR OF SHREDDED WHEAT FACTORY.

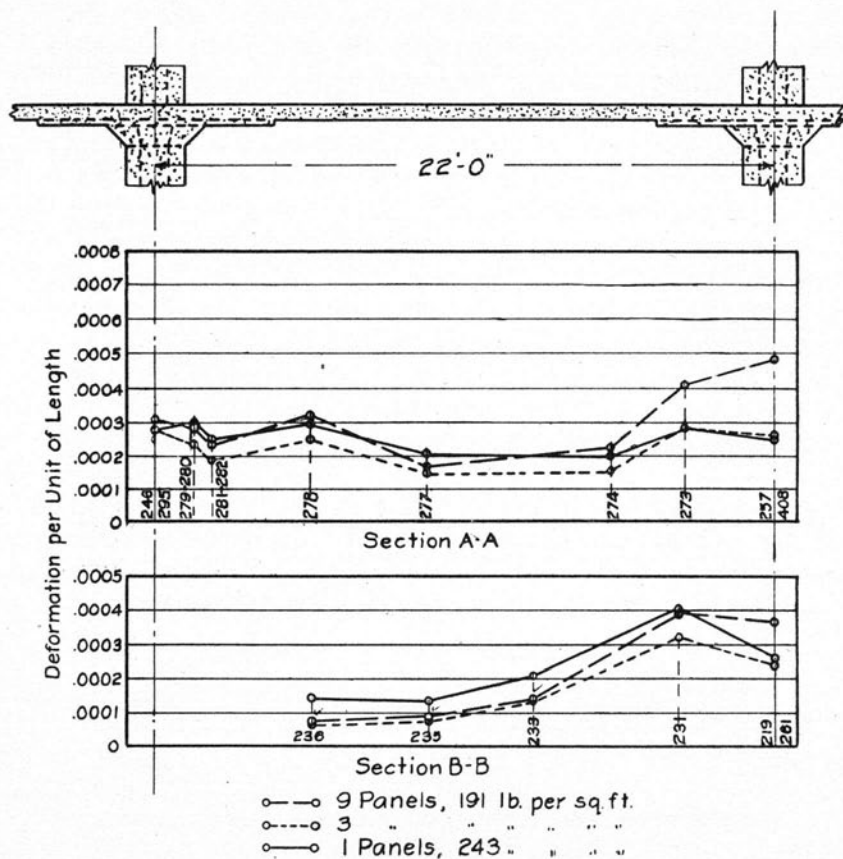
FIG. 12. NORTH-SOUTH DISTRIBUTION OF DEFORMATION IN EAST-WEST BARS ACROSS EDGE OF CENTRAL TEST PANEL IN SHREDDED WHEAT FACTORY.

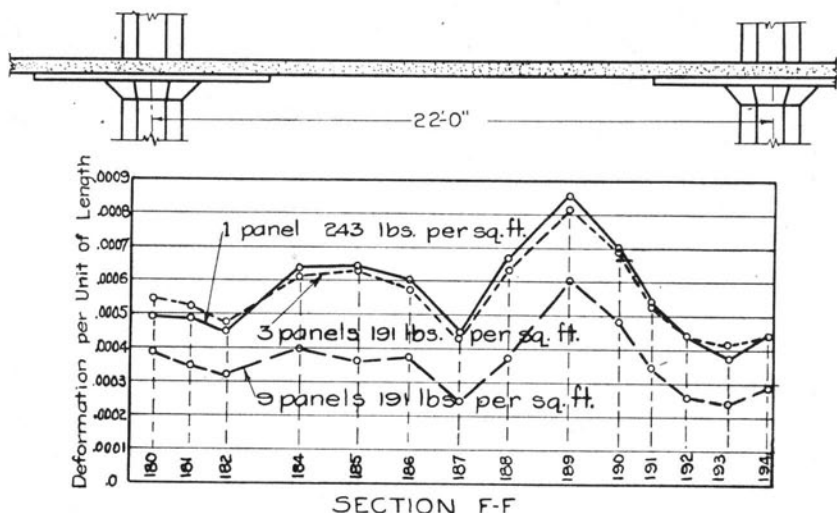
FIG. 13. NORTH-SOUTH DISTRIBUTION OF DEFORMATION IN EAST-WEST BARS ACROSS CENTER LINE OF CENTRAL TEST PANEL IN SHREDDED WHEAT FACTORY.

Fig. 13 and 15 show the deformations in the gage lines which cross the center lines of the central panel (sections F-F and E-E) for the three panels loaded and for the one panel loaded. Fig. 10 and 11 show the change in stress in these sections caused by the changes in loading in per cent of the stress present before moving the load.

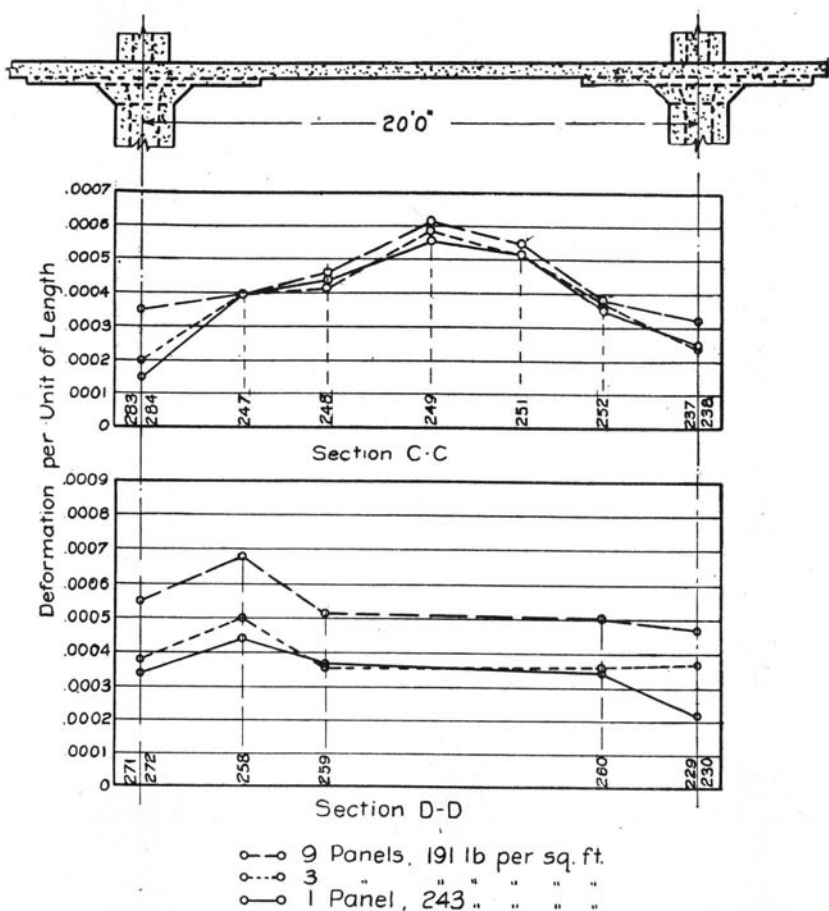
FIG. 14. EAST-WEST DISTRIBUTION OF DEFORMATION IN NORTH-SOUTH BARS ACROSS EDGE OF CENTRAL TEST PANEL IN SHREDDED WHEAT FACTORY.

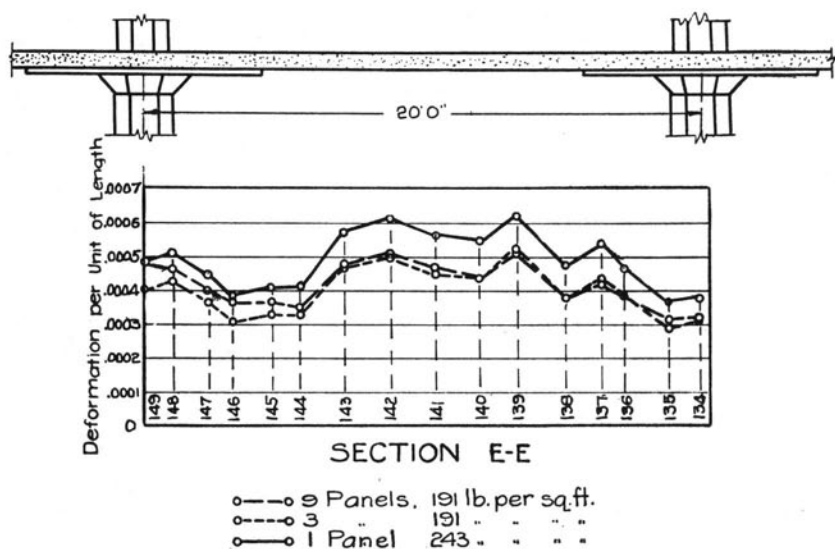
FIG. 15. EAST-WEST DISTRIBUTION OF DEFORMATION IN NORTH-SOUTH BARS ACROSS CENTER LINE OF CENTRAL TEST PANEL IN SHREDDED WHEAT FACTORY.

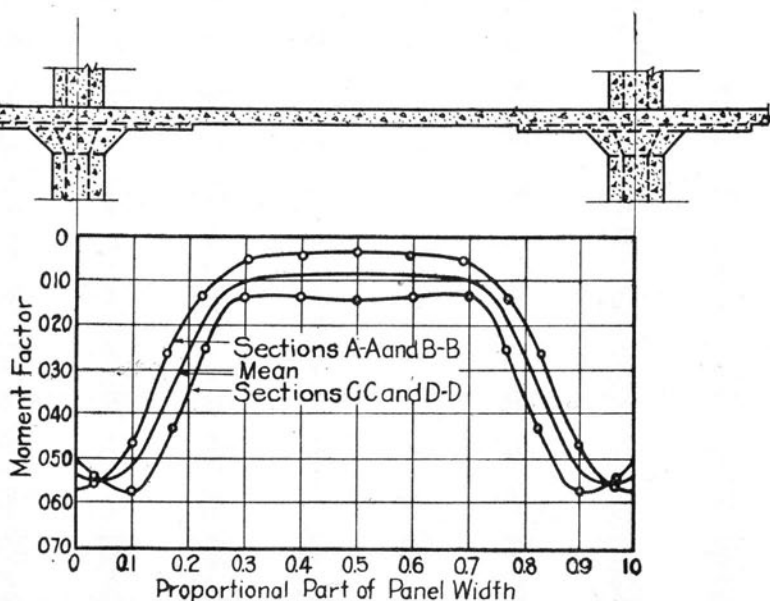
FIG. 17. MOMENT FACTOR DIAGRAM FOR SECTIONS OF NEGATIVE MOMENT (SECTIONS A-A TO D-D), SHREDDED WHEAT FACTORY.

It will be noted that the distribution of the values of the moment factors in Fig. 16 and 17 is largely dependent upon the distribution

By integration of the areas between the moment factor curve and the axis, the value for the positive resisting moment due to the measured stresses in the steel for a width equal to the width of the panel is found to be $0.021 Wl$ and that for the negative resisting moment $0.026 Wl$, where W is the total load on the panel and l is panel length. These moments are the averages of the values obtained from the two curves for the positive moment and from the two curves for negative moment. These moments represent the value of the resisting moment developed by the steel for one direction only, as determined by average unit-deformations over 8-in. gage lengths. With the increased deformations at certain places when only three panels were loaded the average positive moment would be found to

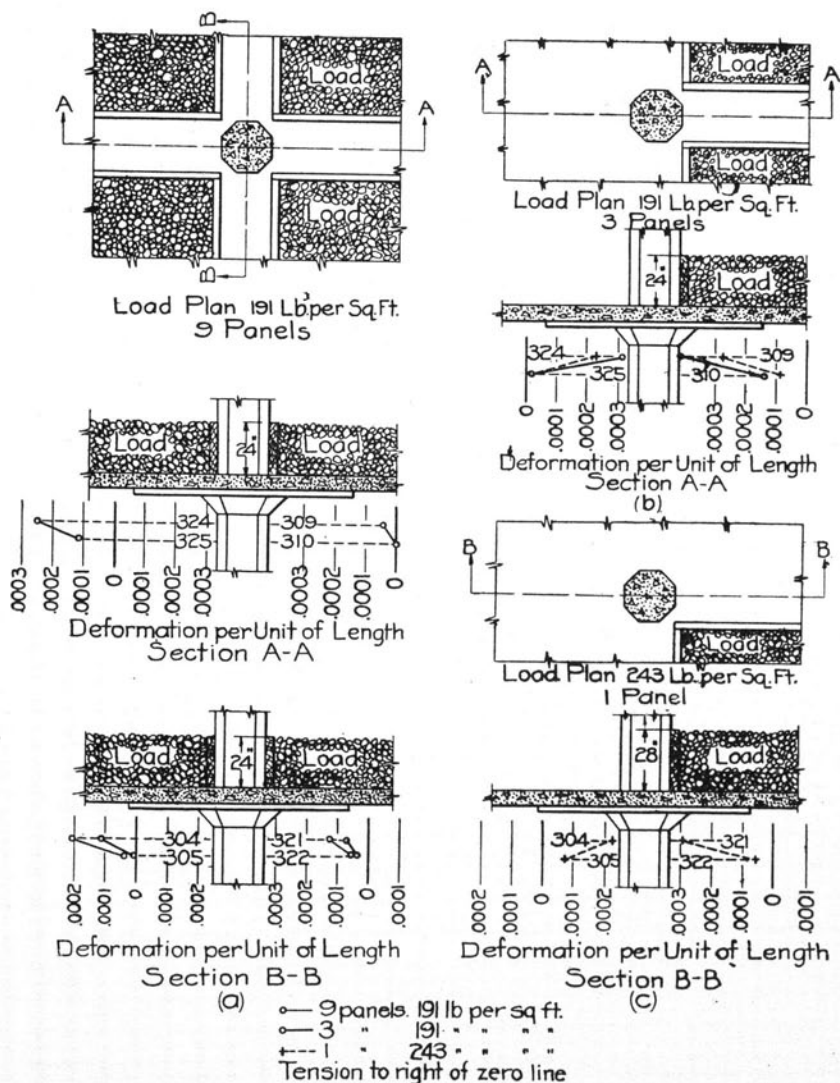
FIG. 18. DEFORMATIONS IN INTERIOR COLUMN NO. 68 OF SHREDDED WHEAT FACTORY.

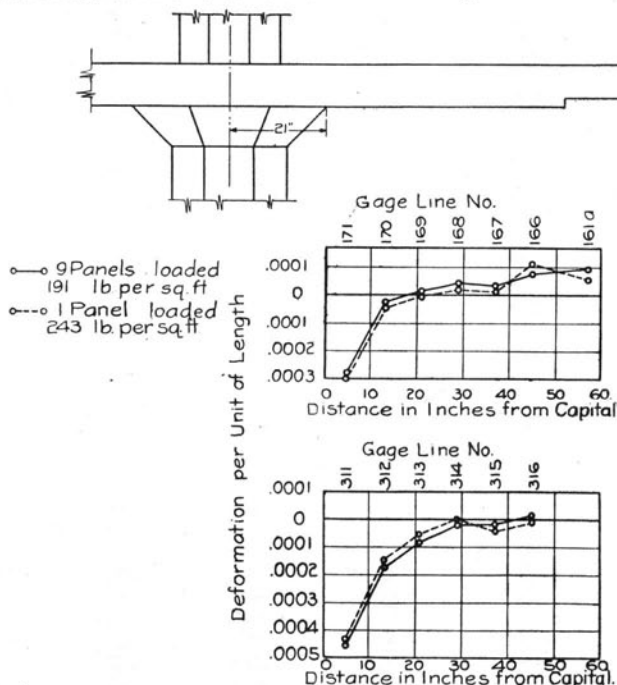
FIG. 21. POINTS OF ZERO UNIT-DEFORMATION ON UNDER SURFACE OF TEST FLOOR NEAR INTERIOR COLUMNS OF SHREDDED WHEAT FACTORY.

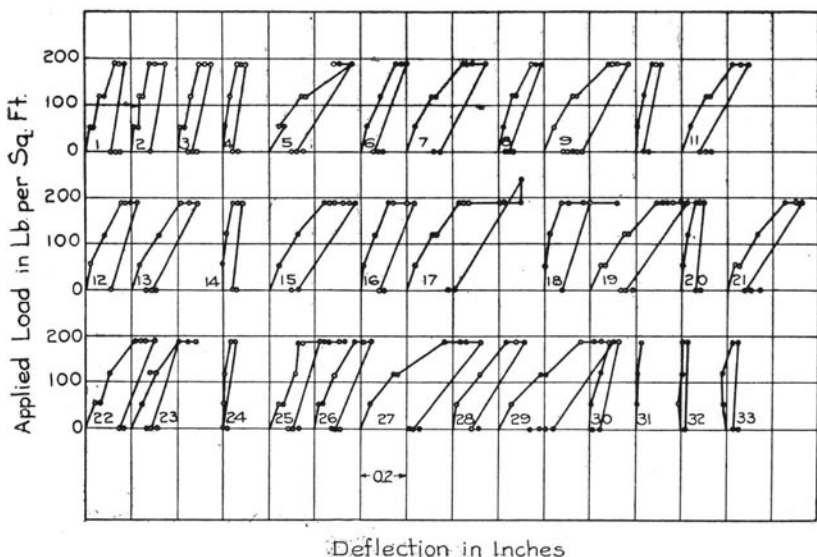
FIG. 22. LOAD-DEFLECTION DIAGRAMS FOR TEST FLOOR OF SHREDDED WHEAT FACTORY.

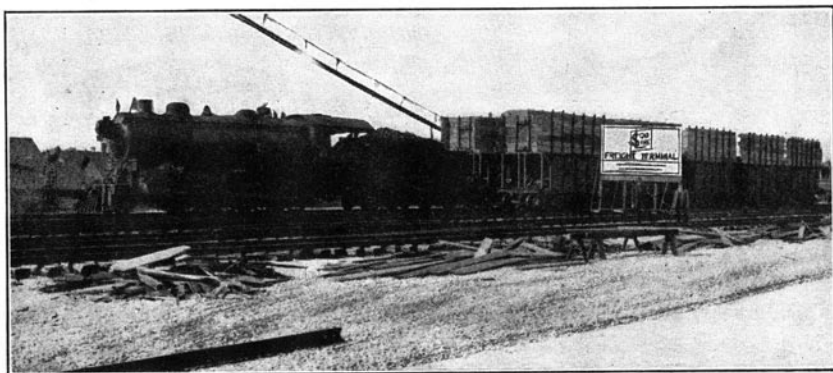
FIG. 23. VIEW OF TEST LOAD, SOO TERMINAL STRUCTURE.

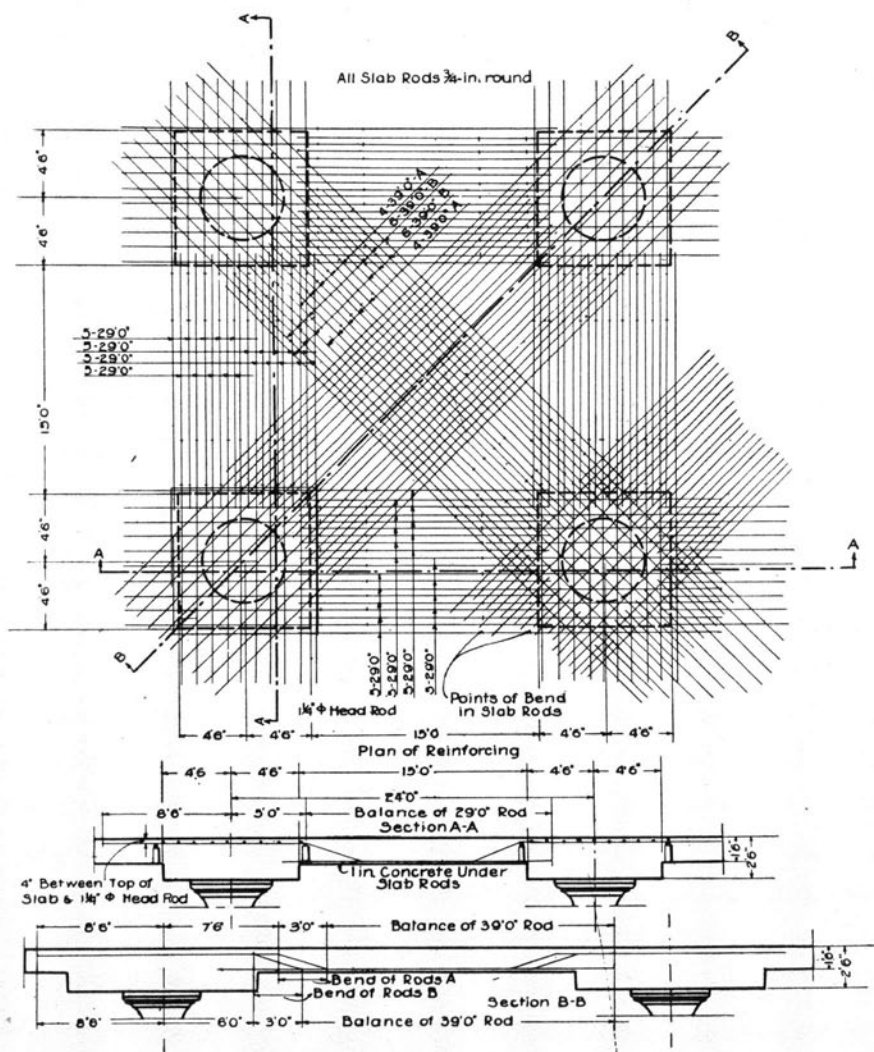
FIG. 25. DIMENSIONS AND REINFORCEMENT OF TYPICAL PANEL OF SOO TERMINAL TEST FLOOR.

The general plan of the structure is shown in Fig. 24 and the design of a typical panel is shown in Fig. 25. For the test a four panel area was chosen which represents the typical flat slab of this structure, which is an unusually heavy one. The test area was located between West Fourteenth Street and Barber Street,

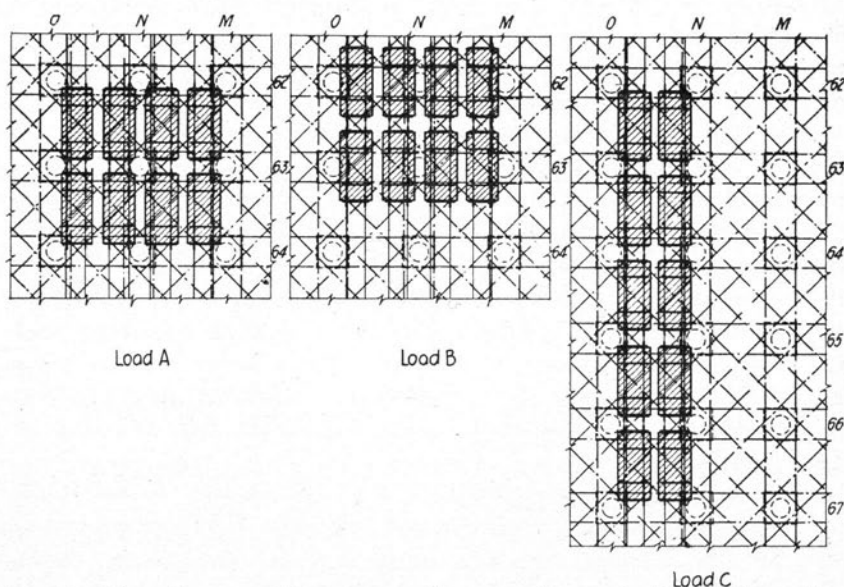
FIG. 26. PLAN SHOWING POSITIONS OF CARS FOR LOADS A, B, AND C ON SOO TERMINAL TEST FLOOR.

The three different positions of load, designated as A, B, and C, are indicated in Fig. 26. Load A was designed to give the representative stresses around a central column approaching the condition of

In the four-panel loading (see plan of load A, Fig. 26) the bars in a band of reinforcement which has load on both sides of it (as the rectangular band from Column N62 to N63 and on to N64, and also the rectangular band from Column M63 to N63 and on to O63) may be expected to take their full share of the stresses due to the load. In bands at the edge of the loaded area (as in the band extending from Column O62 to O63 to O64) the bars at the edge of the band which lie within the loaded area will be stressed higher than the bars at the other edge of the same band which lie outside the loaded area, but the latter bars will carry a considerable proportion of stress, and the stresses developed in the former bars will be materially less than if the latter bars were not present. This condition will need to be taken

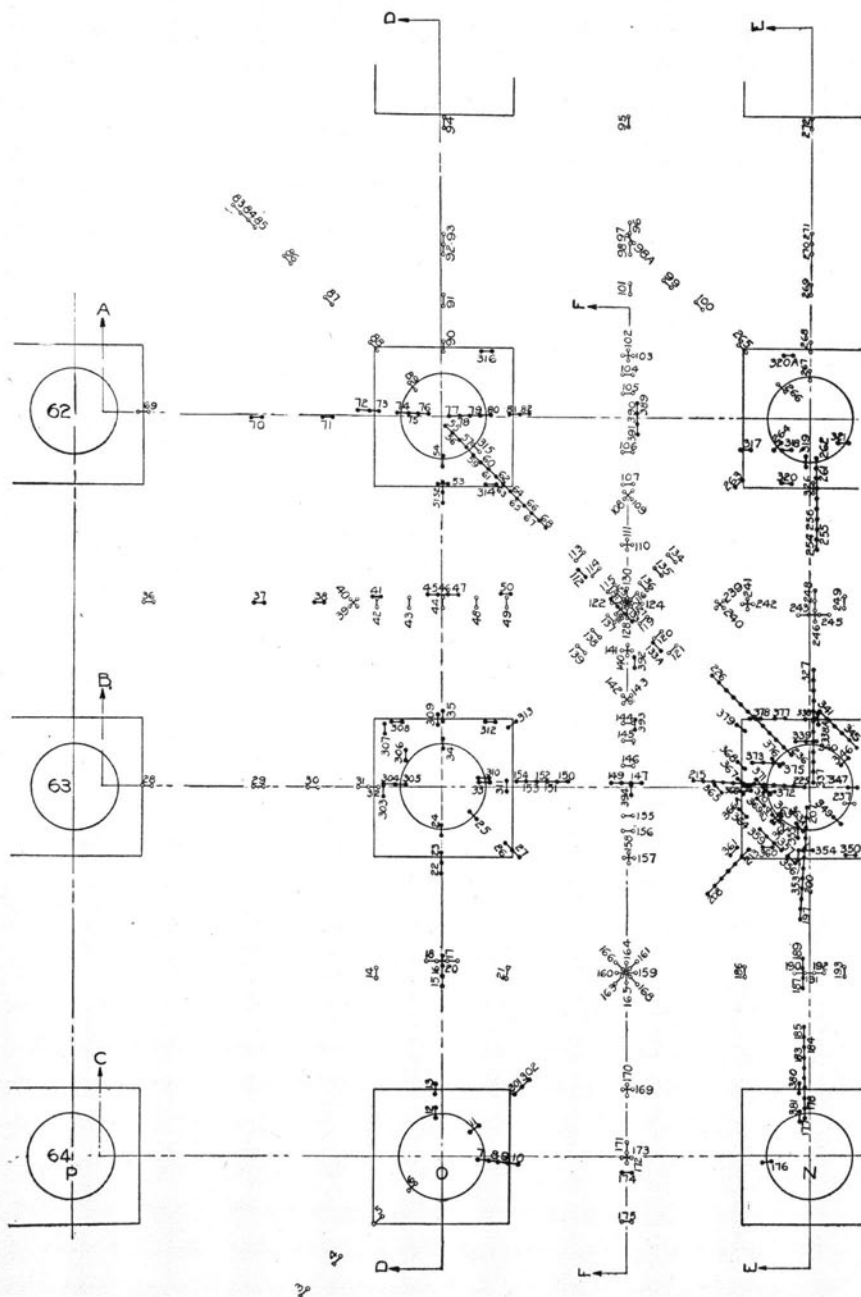
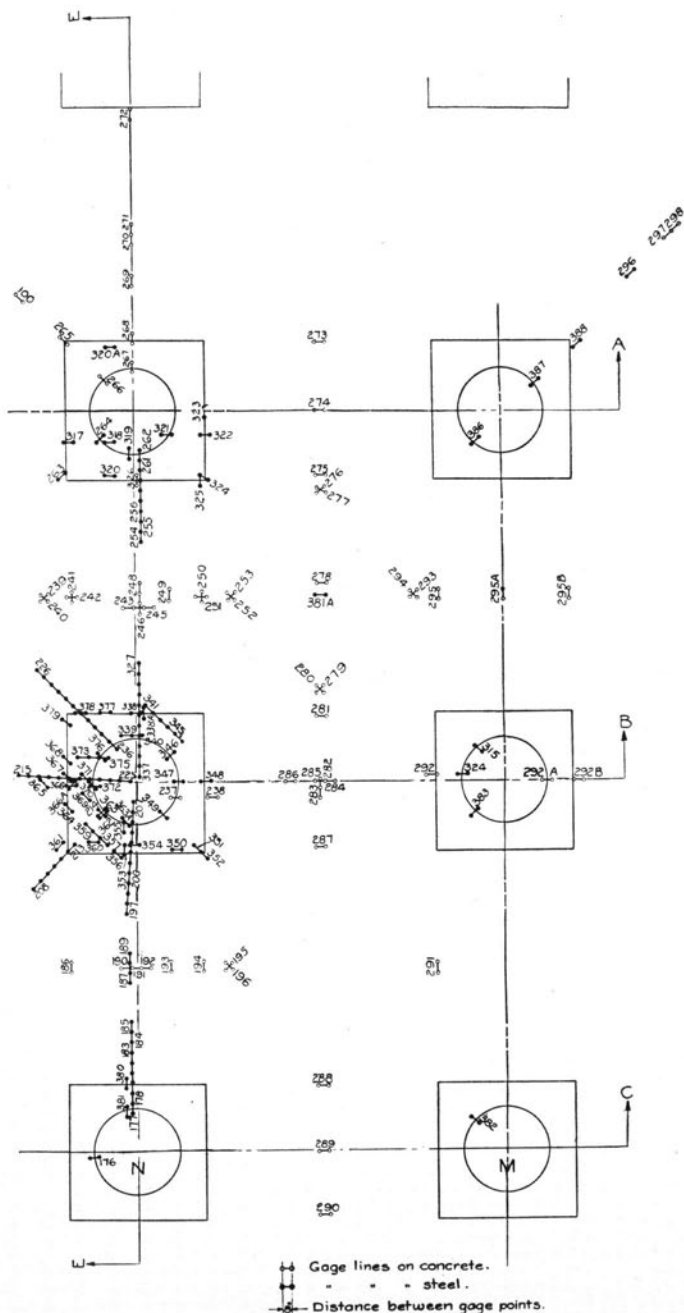
FIG. 27. LOCATION OF GAGE LINES

ON UPPER SURFACE OF SCO TERMINAL TEST FLOOR.

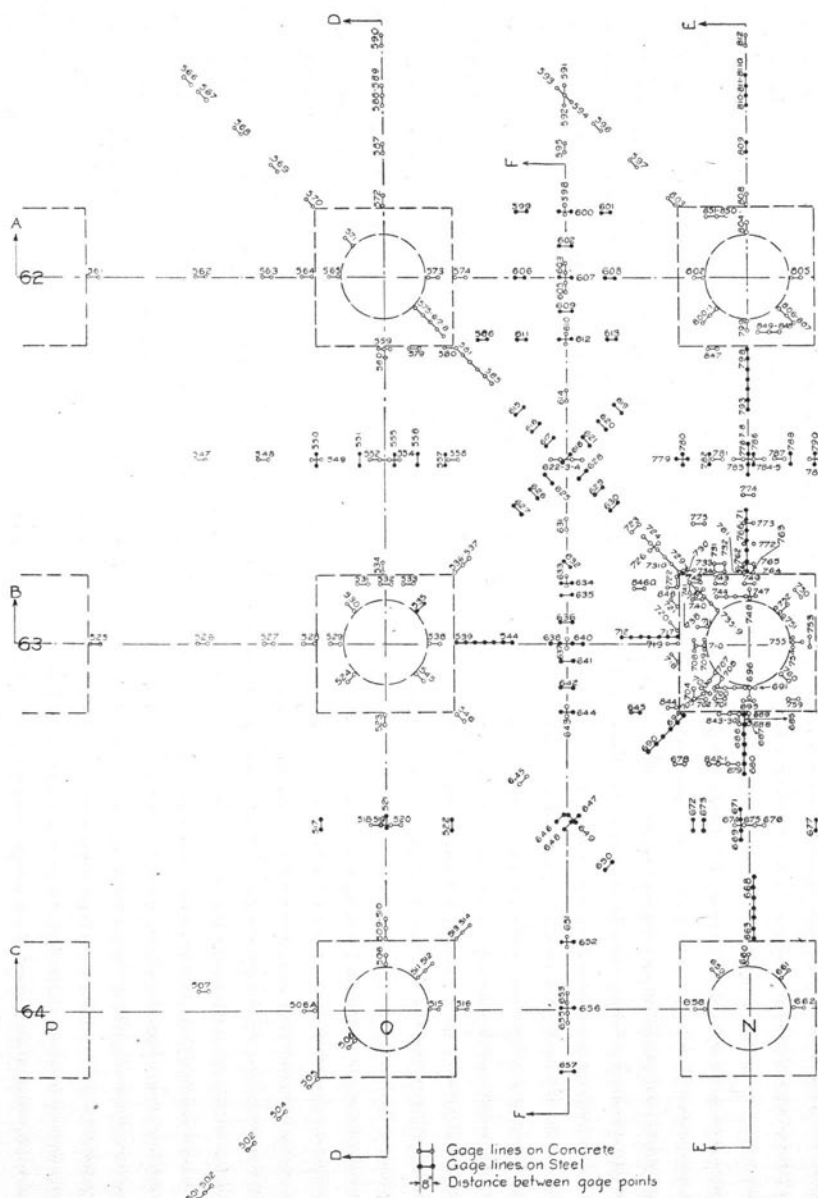
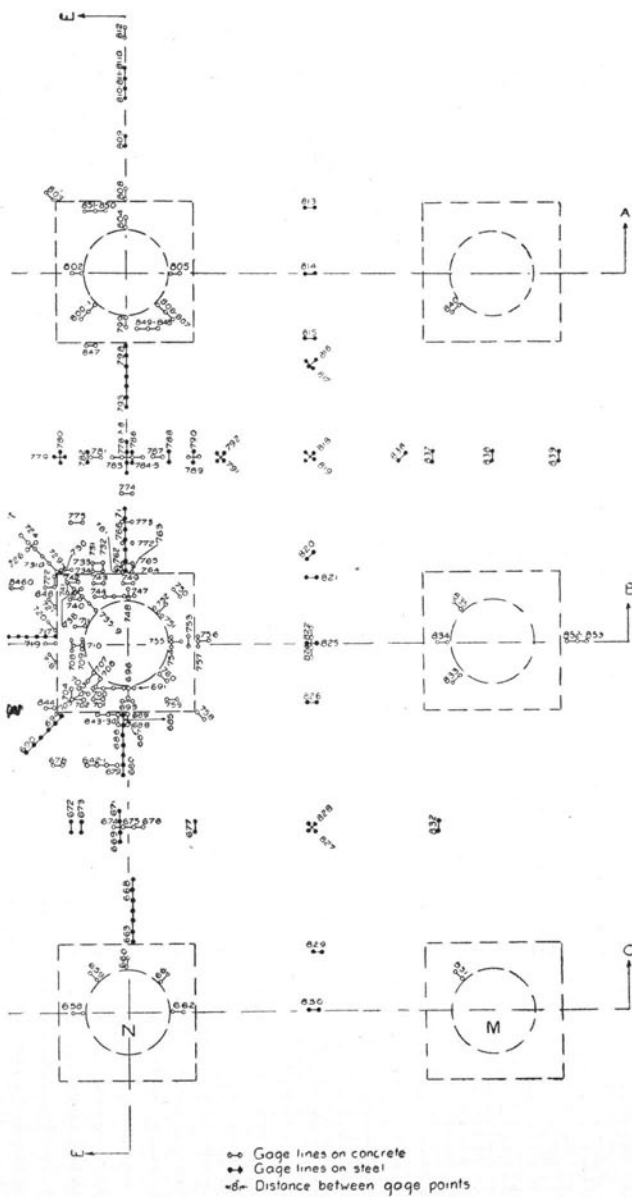
FIG. 28. LOCATION OF GAGE LINES

ON UNDER SURFACE OF S00 TERMINAL TEST FLOOR.

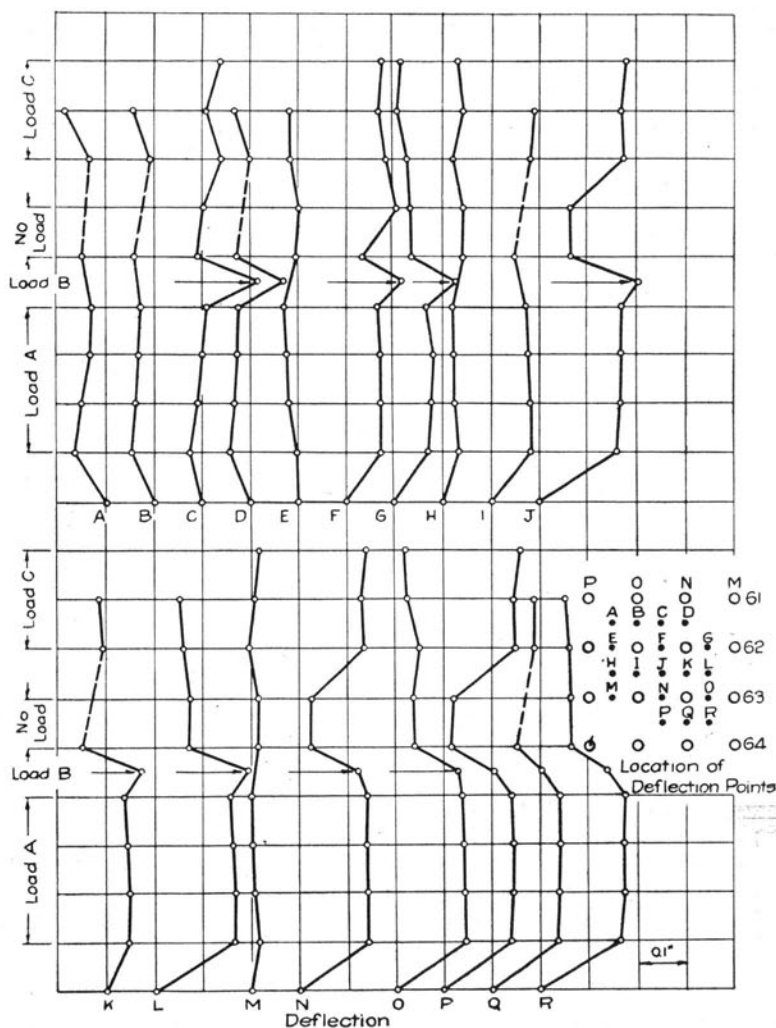
FIG. 30. DEFLECTION OF TEST FLOOR AT POINTS MIDWAY BETWEEN COLUMNS OF SOO TERMINAL STRUCTURE.

The data of settlement and deflections are given in Fig. 29 and 30. The maximum settlement indicated by the level notes was 0.04 feet which appears to have occurred at Column N63, the central column of the four-panel test area. The almost complete recovery from this settlement on removal of the load and the large amount of recovery during the time from 11:00 a. m. to 6:00 p. m., October 2, while the full load was in place, seem improbable and hence raise serious question as to whether as much settlement as that indicated above was present at any time. Besides, the maximum measured deflection of 0.14 in. is so small as to make this value also seem not to represent the actual deflection. However the settlement is not large for buildings on Chicago soil. There are many inconsistencies between the deflections and settlements observed at different places and under different loads, and the uncertainty of the conditions makes it futile to attempt to account for the recovery from settlement or otherwise to interpret the data. However, Fig. 29 and 30 are given for the purpose of record. It is evident that even slight settlement under load will modify the distribution and

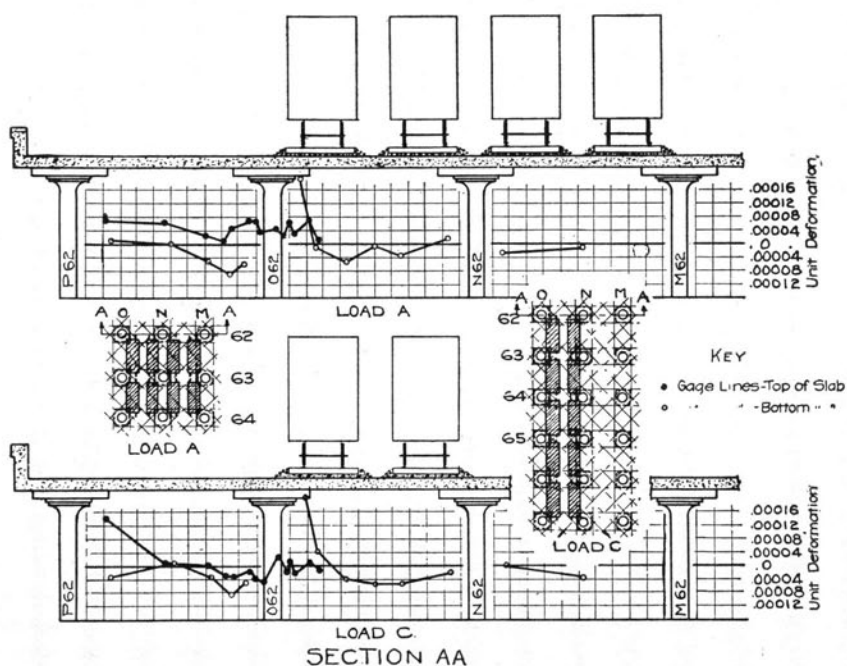
FIG. 31. DEFORMATION ALONG SECTION A-A (NORMAL TO TRACKS) OF SOO TERMINAL TEST FLOOR.

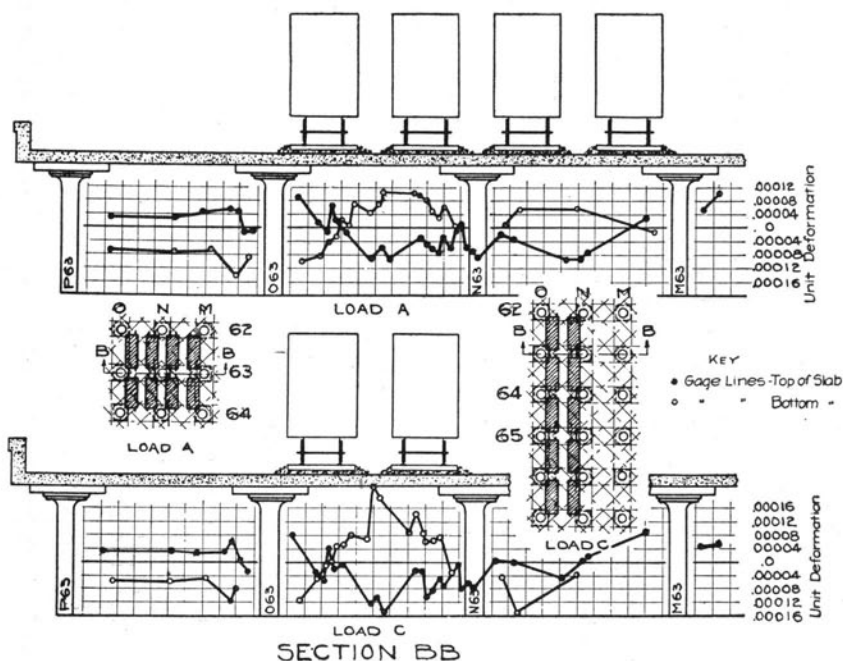
FIG. 32. DEFORMATION ALONG SECTION B-B (NORMAL TO TRACKS) OF SOO TERMINAL TEST FLOOR.

Some of the difficulties may be seen from the following examples. For the negative bending moment around the central column (column N63, Fig. 32), with four panels loaded, the compressive stresses in the concrete due to both dead and live loads would not be expected, from calculations made according to current practice, to exceed 500 lb. per sq. in. If the concrete on the tension side remained intact, the tensile stresses in the concrete in this region would be less than this amount and the stresses in the reinforcement would be correspondingly low. As no cracks were observed in these positions and as the observed tensile deformations here were very small, it seems probable that the tensile strength of the concrete was sufficient

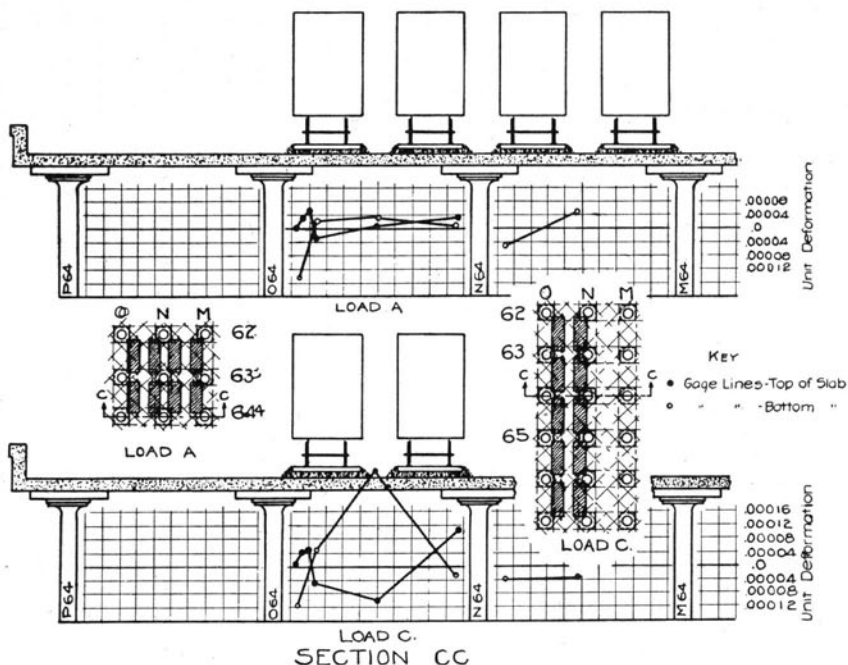
FIG. 33. DEFORMATION ALONG SECTION C-C (NORMAL TO TRACKS) OF 500 TERMINAL TEST FLOOR.

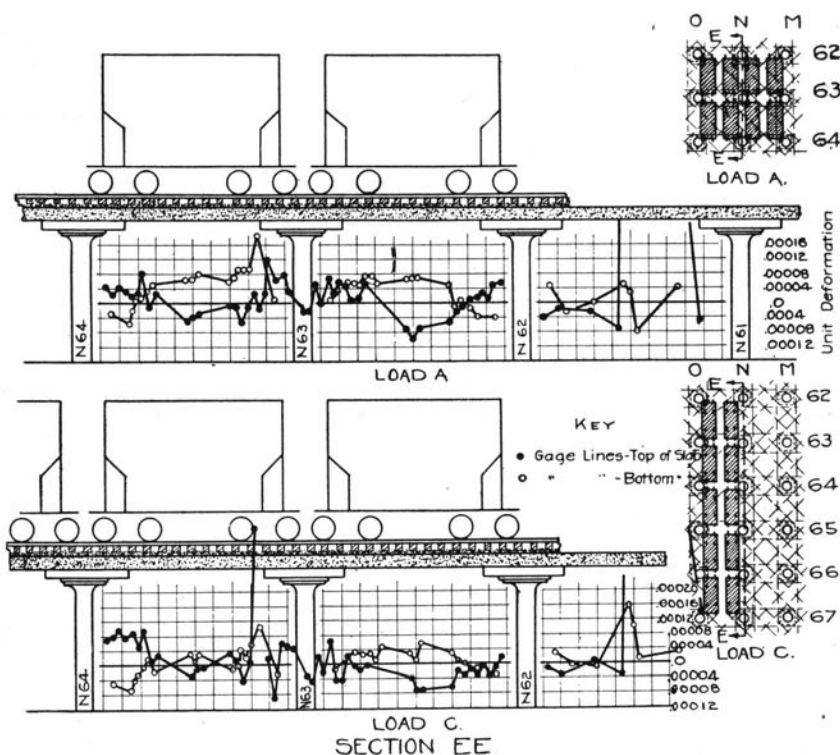
FIG. 34. DEFORMATION ALONG SECTION E-E (PARALLEL TO TRACKS) OF S00 TERMINAL TEST FLOOR.

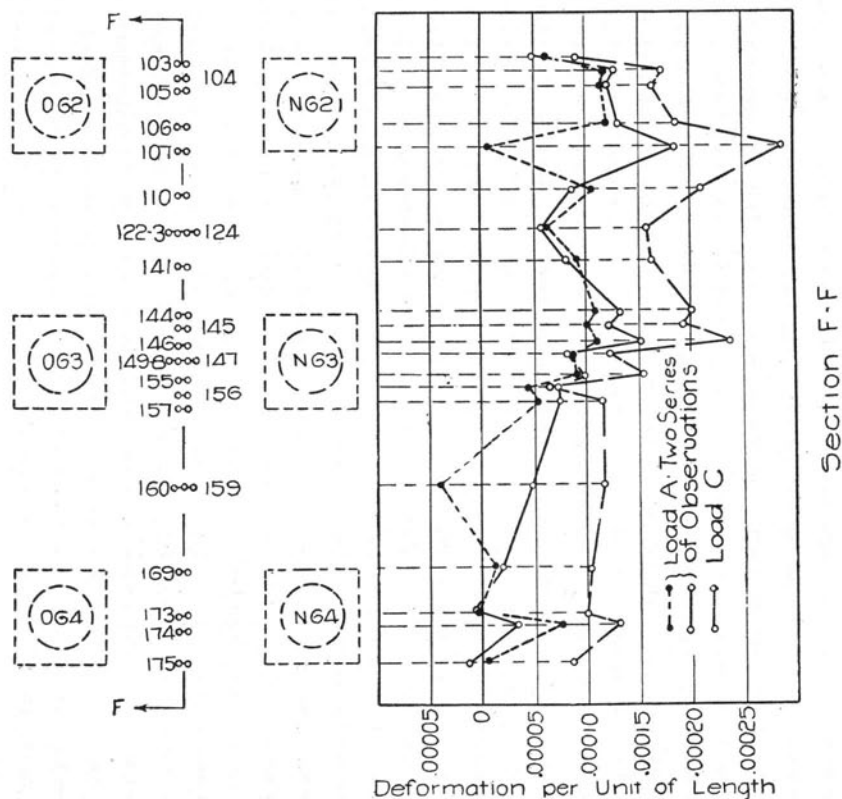
FIG. 35. EFFECT OF CHANGE FROM LOAD A TO LOAD C ON DEFORMATION IN GAGE LINES CROSSING SECTION F-F ON TOP OF SOO TERMINAL TEST FLOOR.

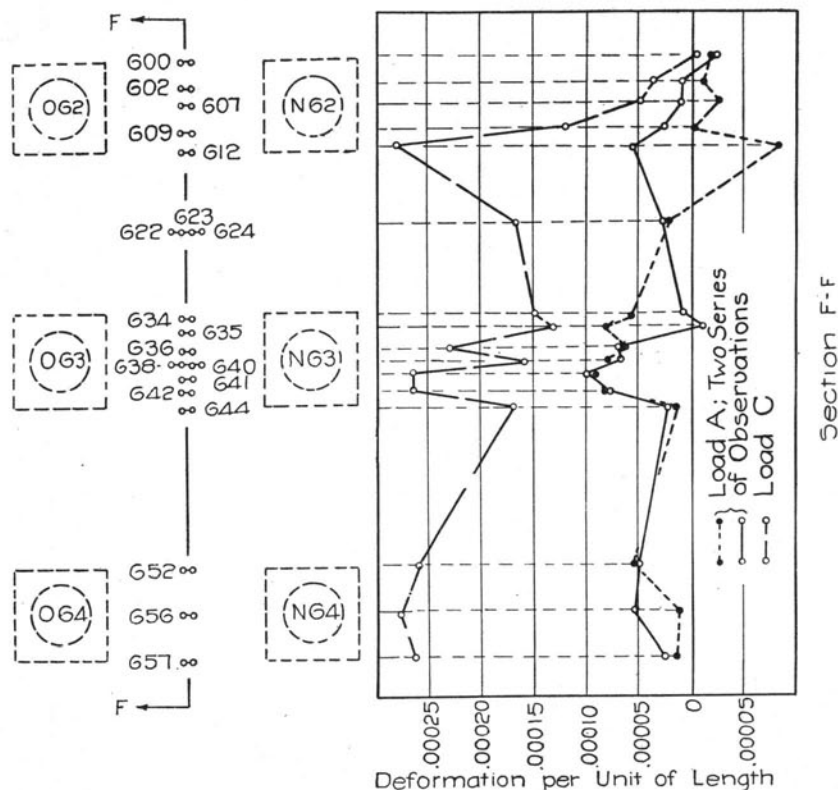
FIG. 36. EFFECT OF CHANGE FROM LOAD A TO LOAD C ON DEFORMATION IN GAGE LINES CROSSING SECTION F-F ON BOTTOM OF SOO TERMINAL TEST FLOOR.
